TECHNICAL MEMORANDUM

Re: **Truckee River Conditions Assessment / SWCA Project No. 71509**

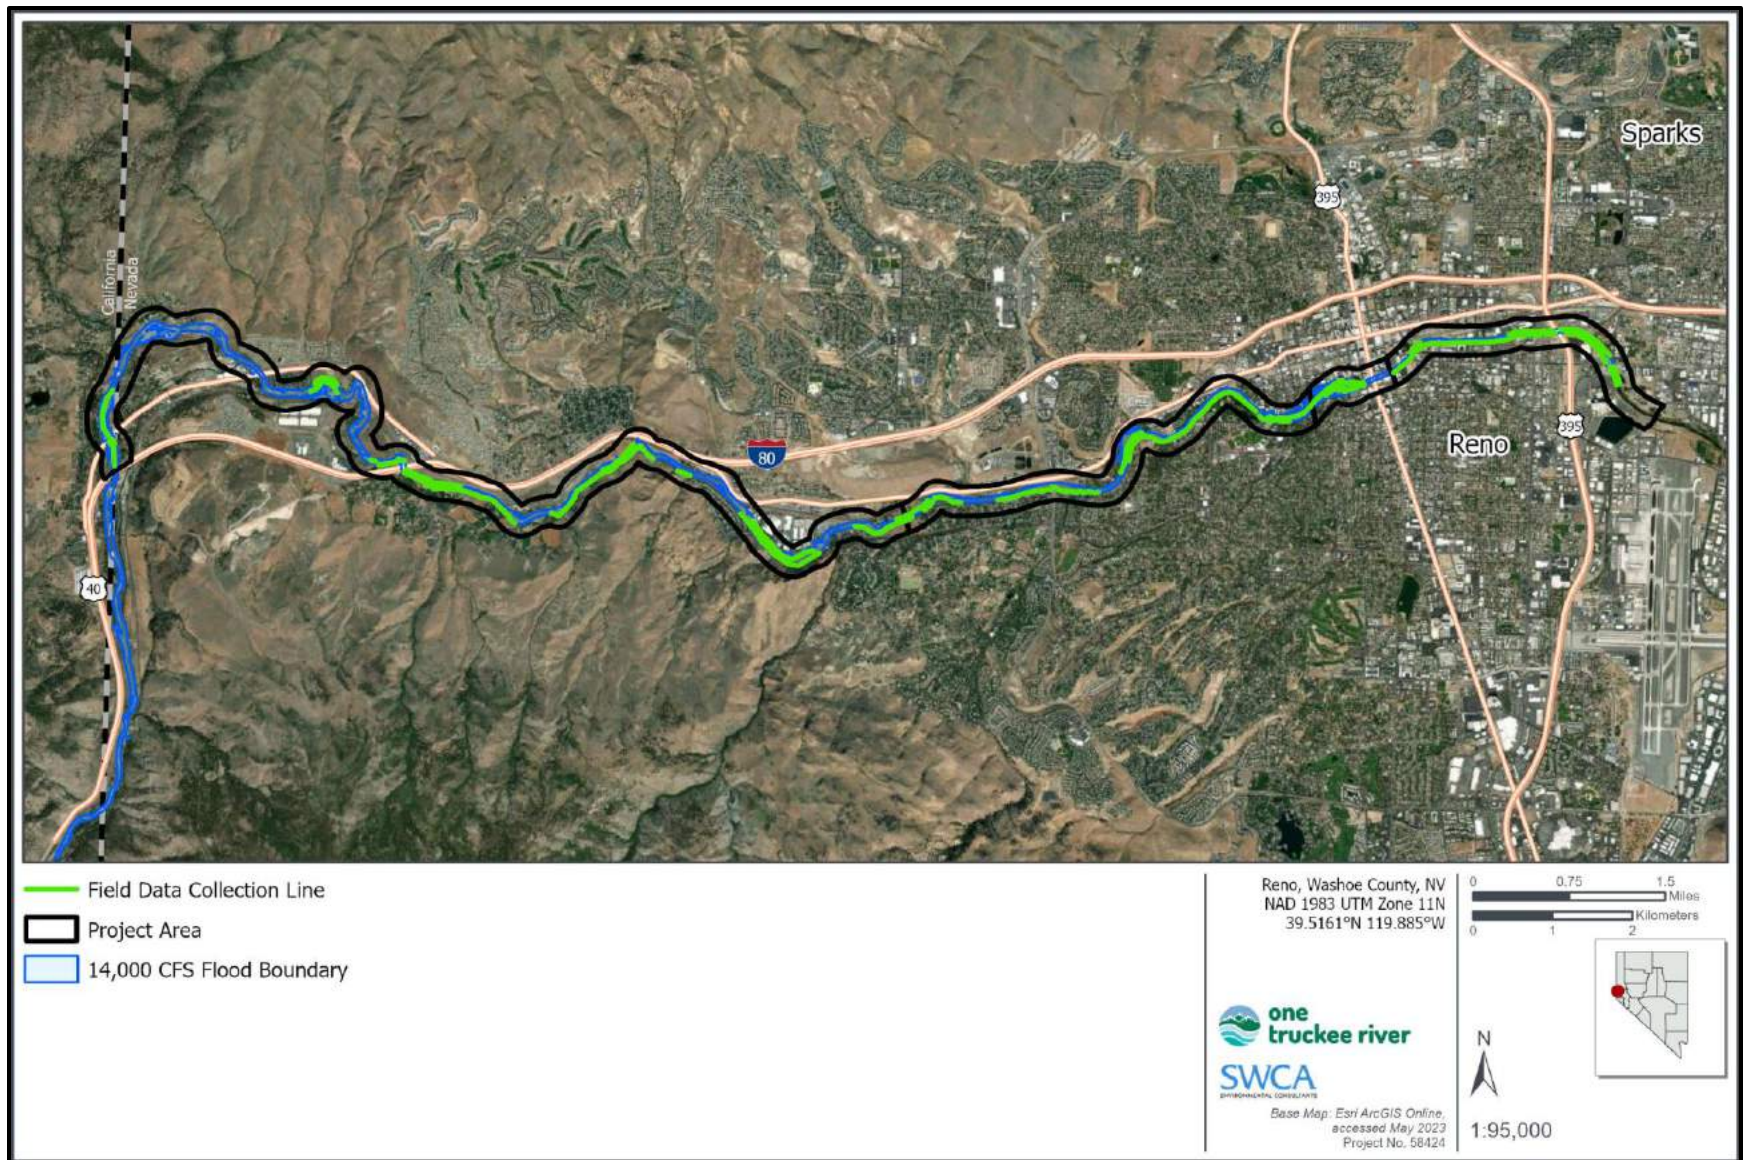
Figure 1. Project area overview.

SWCA performed an assessment of current river bank conditions (conditions assessment) through a combination desktop and field-based data collection and analysis. This assessment focused on the area under the CTWCD's direct jurisdiction within the 14,000-cfs conveyance zone from Crystal Peak Park to Glendale, an area that covers a portion of the geographic scope of OTR's *Framework Plan*. Both desktop and field-based data collection were limited to public parcels only, as these are the areas that could most immediately be accessed and addressed by future restoration efforts. See the project area delineated in Figure 1.

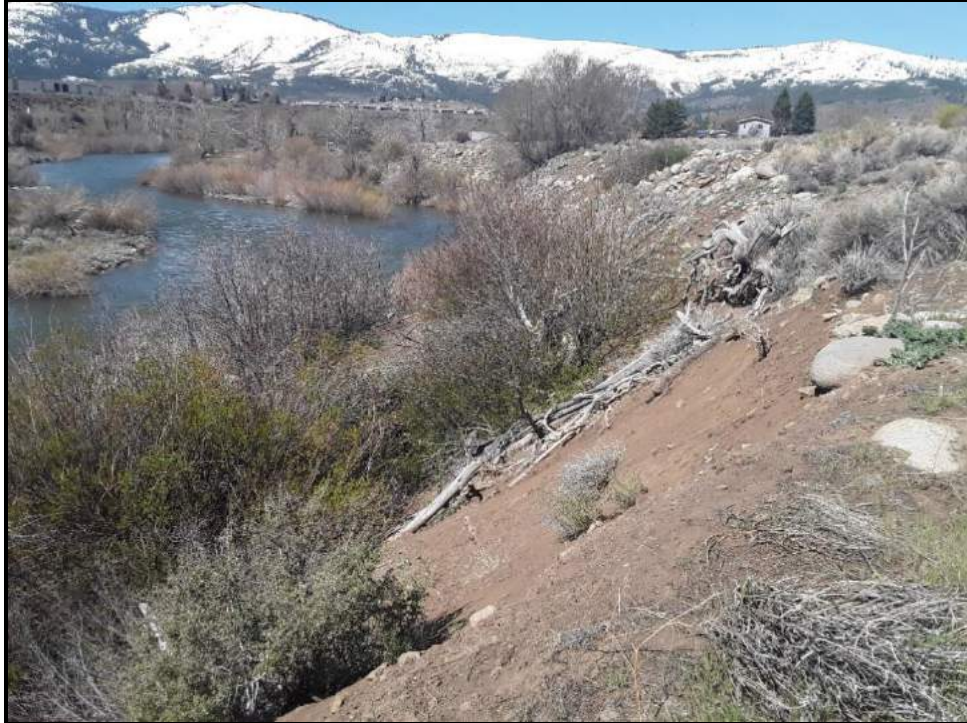
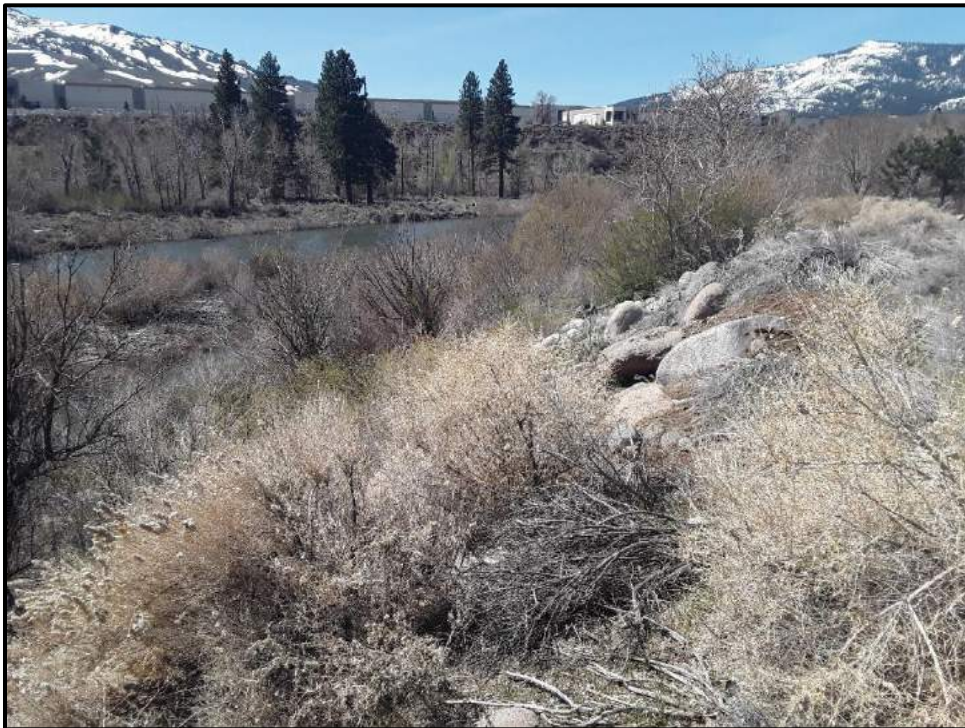
Photograph A-1. Verdi roundabout parcel. Washoe County, L13, L14. Steep river bank with high cover of debris on the slope (L14).

Photograph A-2. Verdi roundabout parcel (L14).

Restoration Area	Landowner	Parcel Numbers	Line Identification Numbers	Comments
Verdi Roundabout Parcel	Washoe County	3810034	L13, L14	Steep river bank with lots of debris present on the slope. Slope appears unstable and is actively eroding in spots.
Canepa Ranch and adjacent properties	State of Nevada and United States of America	3879001, 3815014, 3815019	L23, L26, L29, L30, L32	West side has a deep cut bank that is actively eroding. Central area is flatter with alternating patches of grass and shrubs; this could be a vegetation restoration opportunity. Perennial pepperweed (<i>Lepidium latifolium</i>) present on east side.
Idlewild Drive East of Ivan Sack Park	City of Reno	Not applicable	L123, L124, L125, L126	Steep bank with placed rock throughout and visible active erosion in sections.
Between Booth Street Bridge and Keystone Street Bridge	City of Reno	1113206	L139	Steep slope and cut bank with lots of bare soil, actively eroding.

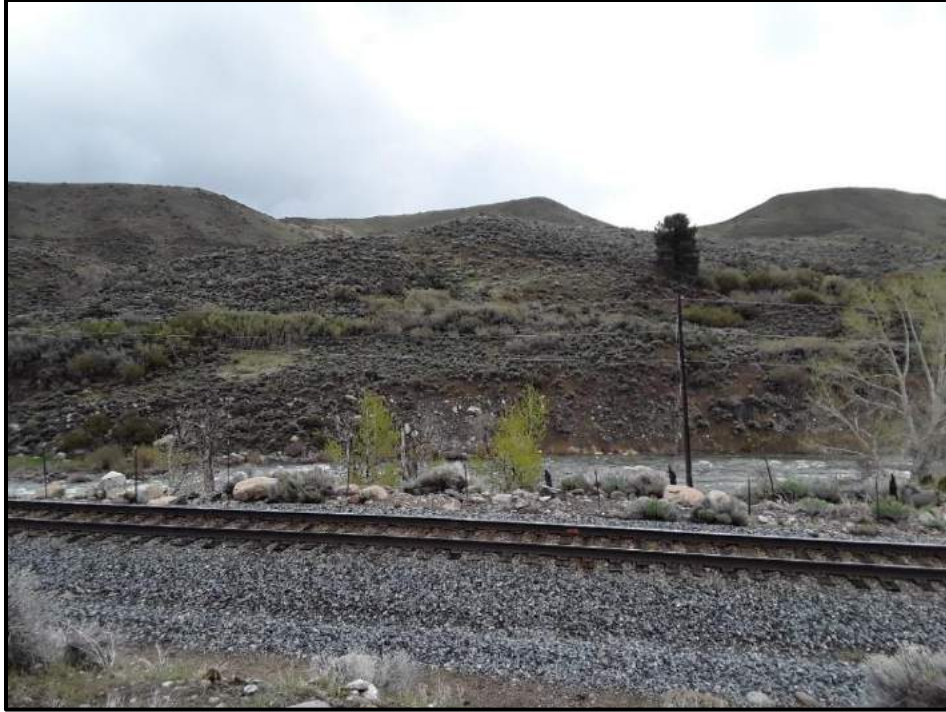
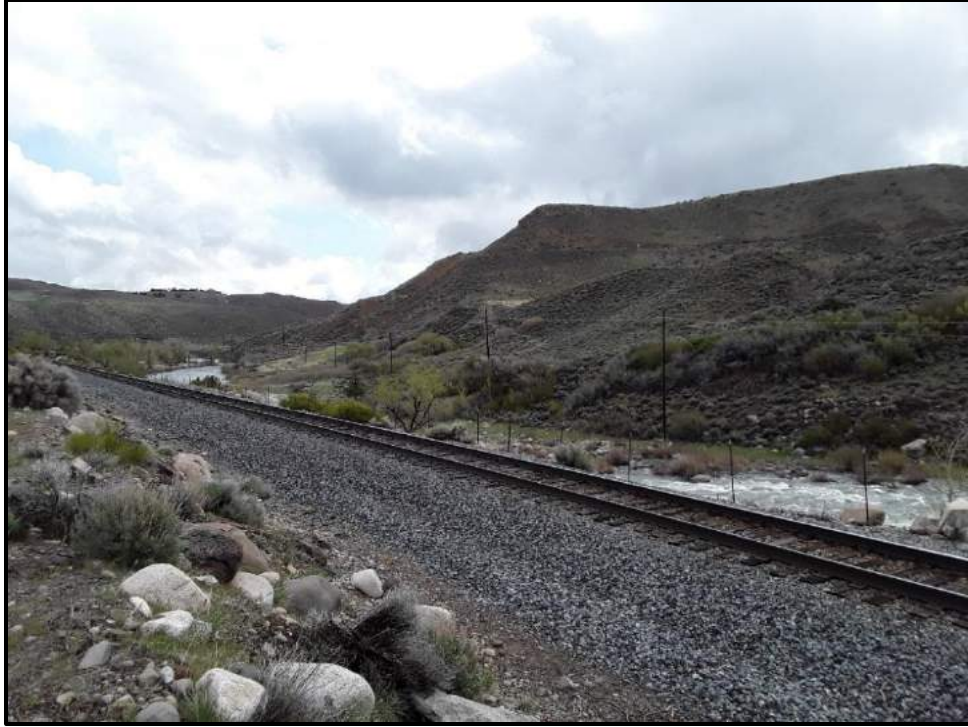
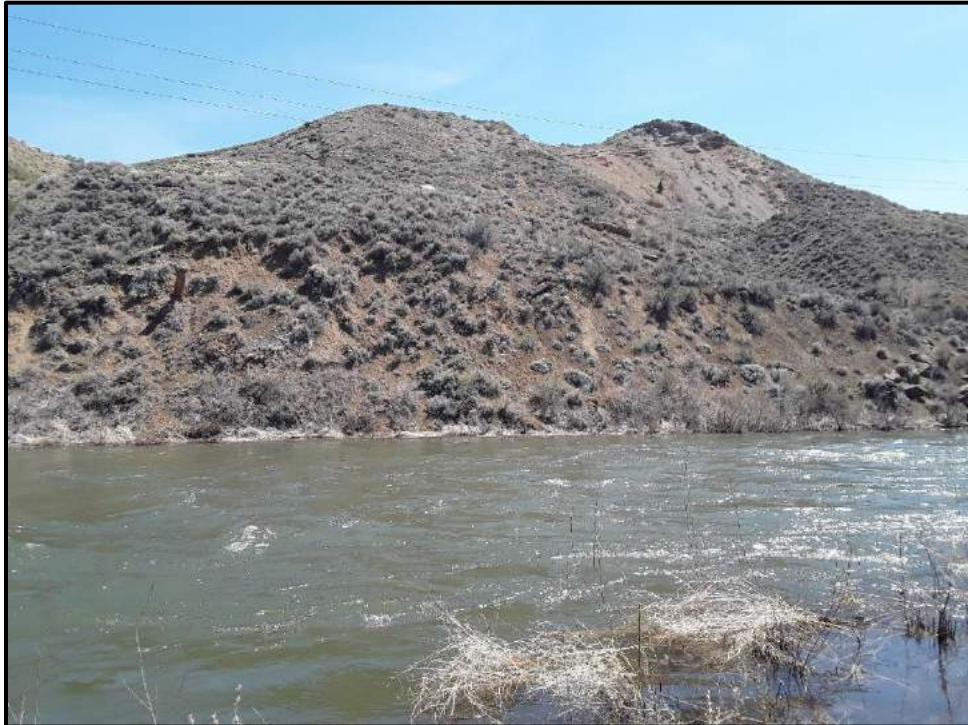
Photograph A-3. Canepa Ranch and adjacent properties. State of Nevada and United States of America, L23, L26, L29, L30, L32. West side has a deep cut bank that is actively eroding. Central area is flatter with alternating patches of grass and shrubs; possible vegetation restoration opportunity. Perennial pepperweed present on east side (L29).

Photograph A-4. Canepa Ranch and adjacent properties (L30).

Photograph A-5. Canepa Ranch and adjacent properties (L23).

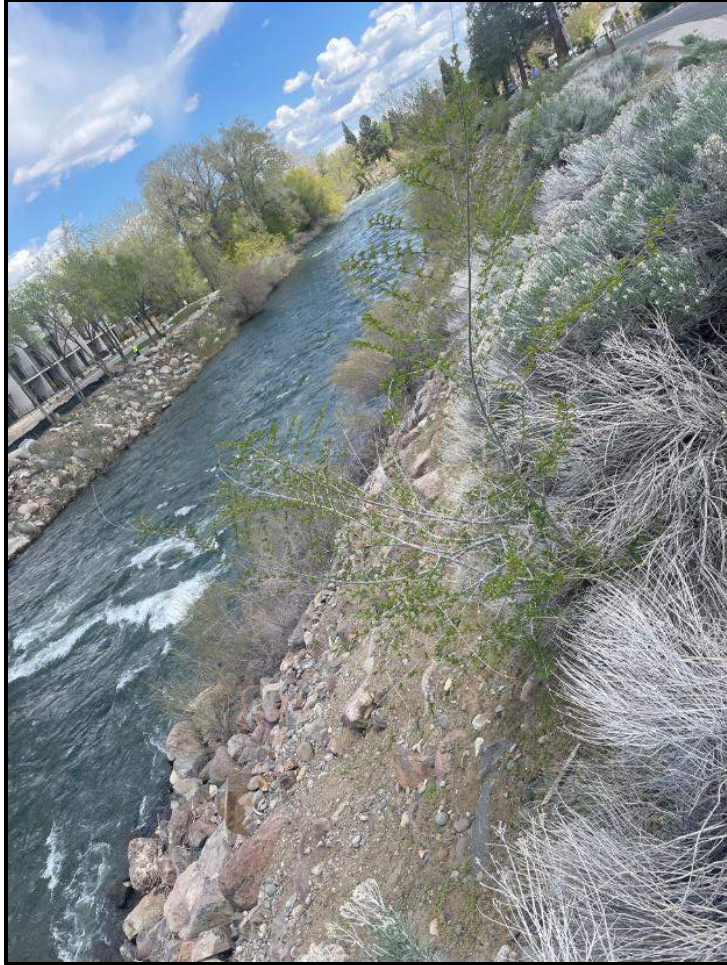
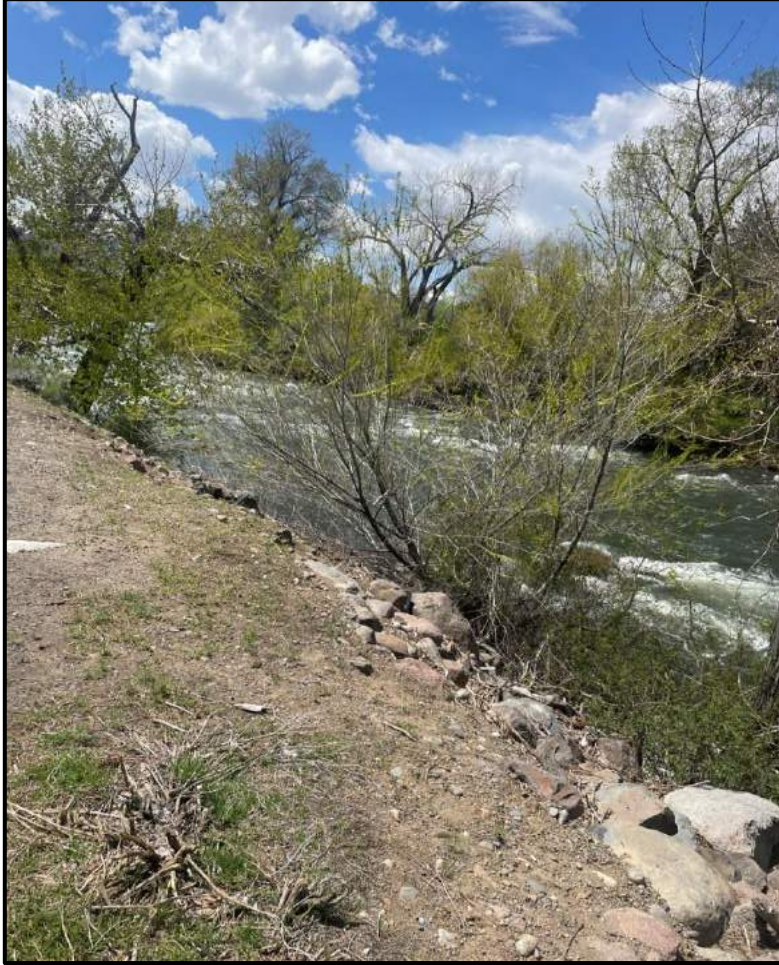
Photograph A-6. Idlewild Drive east of Ivan Sack Park. City of Reno, L123, L124, L125, L126. Steep bank with placed rock throughout and active erosion in places (L124).

Photograph A-7. Idlewild Drive east of Ivan Sack Park (L126).

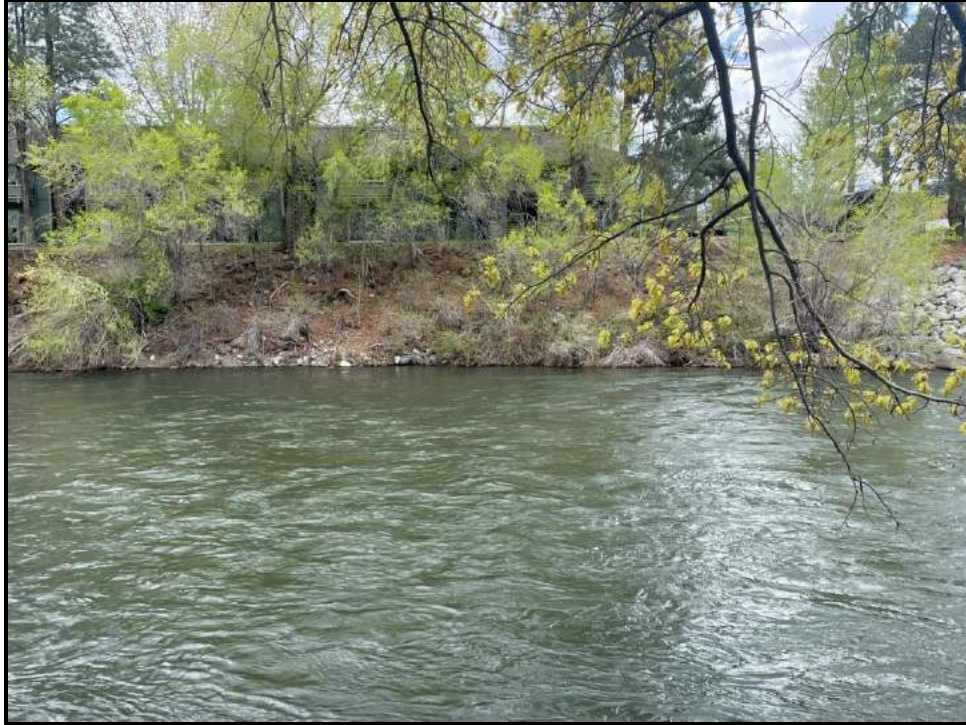
Photograph A-8. Between Booth Street Bridge and Keystone Street Bridge. City of Reno, L139. Steep slope and cut bank with a lot of bare soil and active erosion (L139).

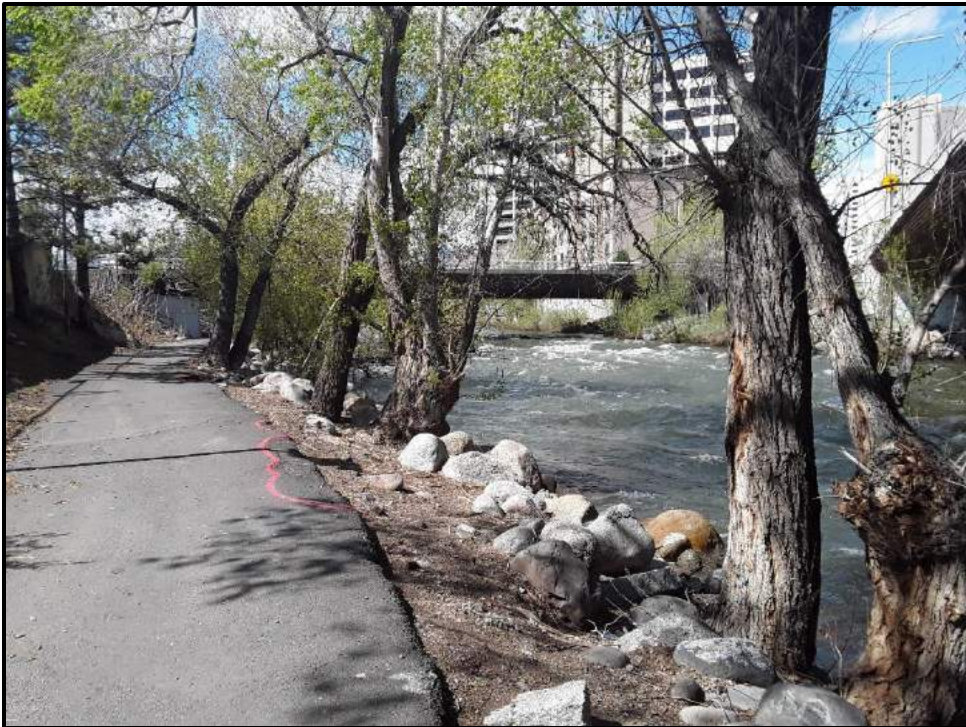
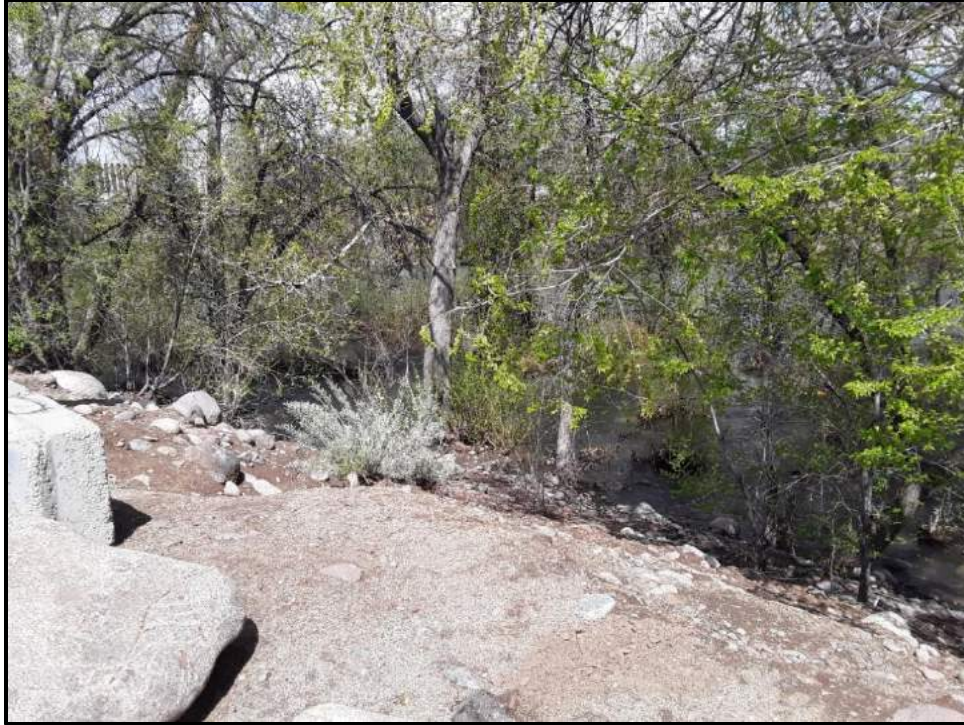
Photograph A-9. Lake Street through Brodhead Park. City of Reno, L63, L64, L66, L67, L68, L69. Steep actively eroding slopes with prominent invasive species (tree of heaven) (L64).

Photograph A-10. Lake Street through Brodhead Park (L68).

Lake Street through Brodhead Park	City of Reno	1201301, 1201509, 1201613	L63, L64, L66, L67, L68, L69	Steep actively eroding slopes with prominent invasive species (tree of heaven, <i>Ailanthus altissima</i>)
Sutro Street through John Champion Park	City of Reno	1205122, 1205130	L73, L74, L75, L76, L77	Many areas have angular riprap placed, and erosion is still present on the steep slopes.
East end of Fisherman's Park	City of Reno and City of Sparks	1230116, 3205054	L92	Steep slope with bare sections and section with riprap. There is very little vegetation present across this area.

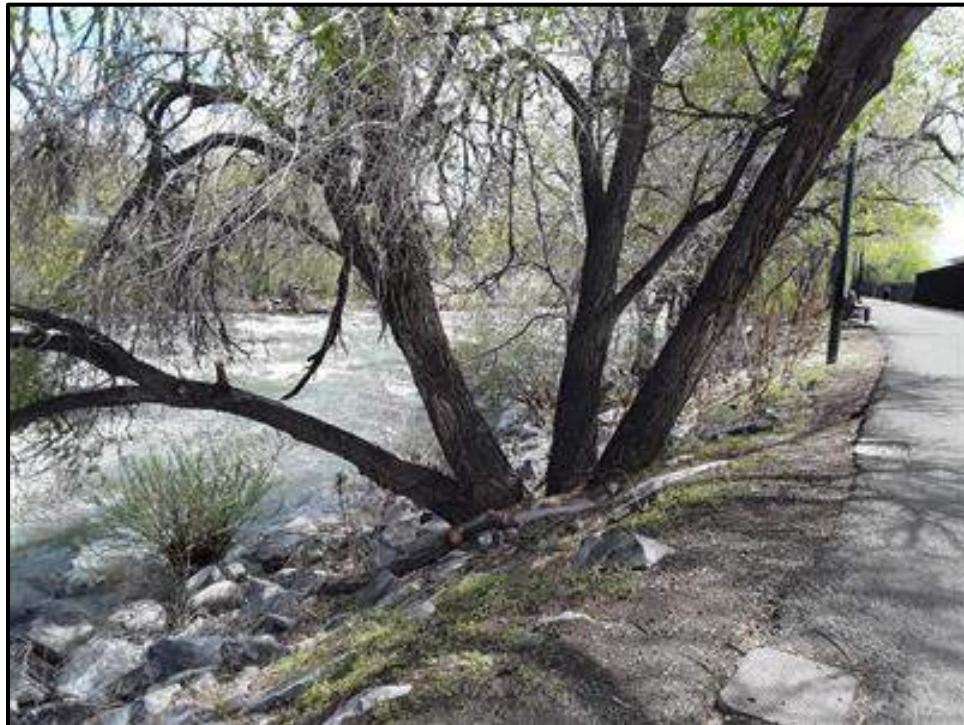
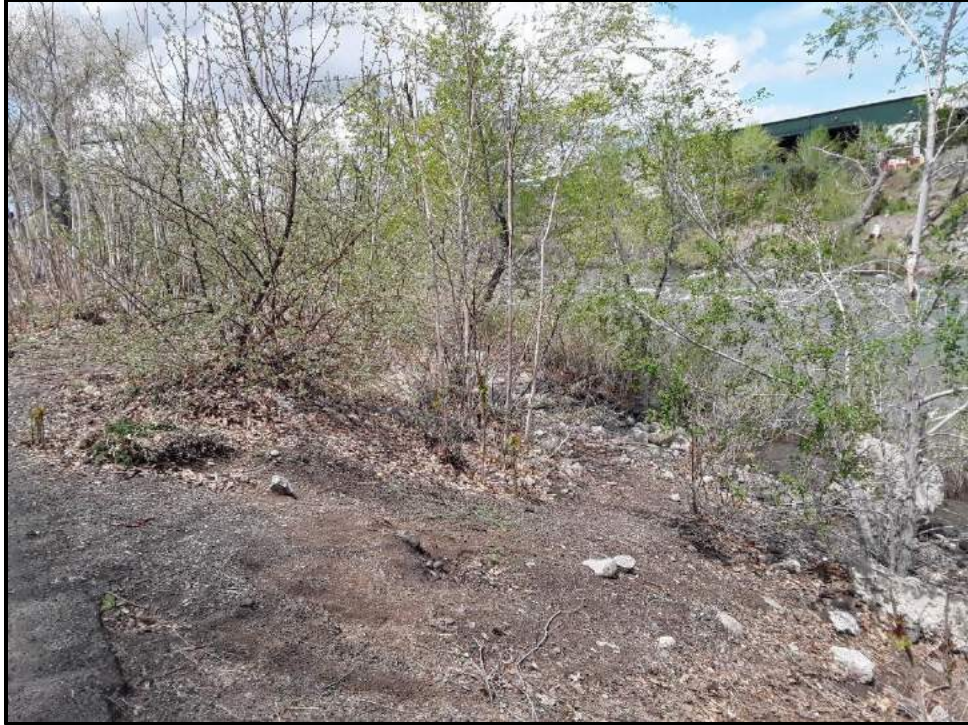
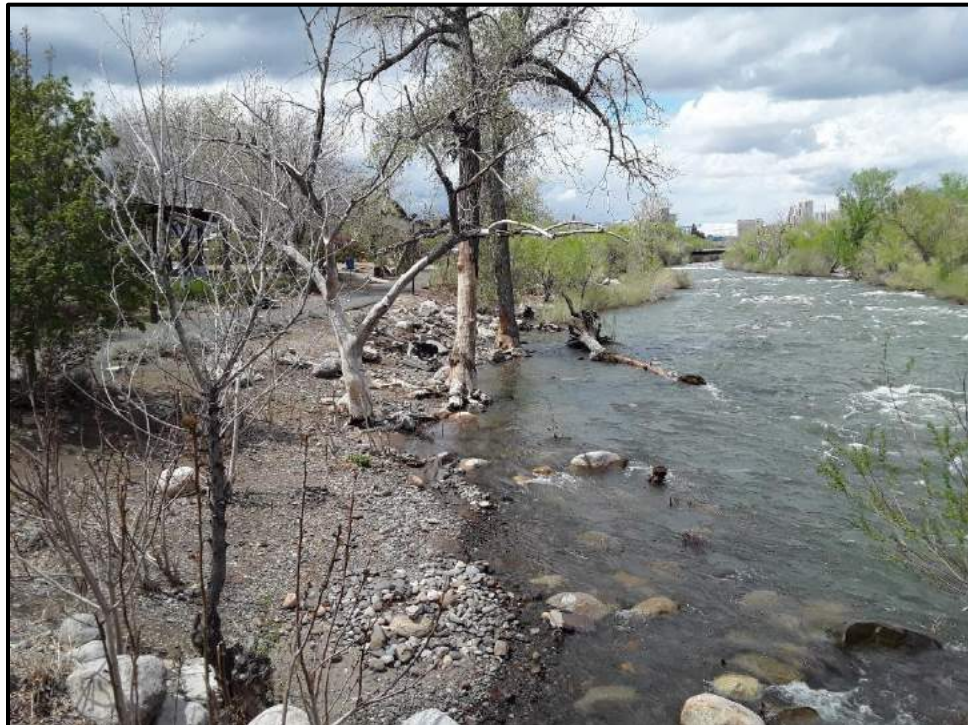
Photograph A-11. Sutro Street through John Champion Park. City of Reno, L73, L74, L75, L76, L77. Angular riprap is placed in many areas, however, erosion is still occurring on the steep slopes (L74).

Photograph A-12. Sutro Street through John Champion Park (L76).

Photograph A-13. Sutro Street through John Champion Park (L77).

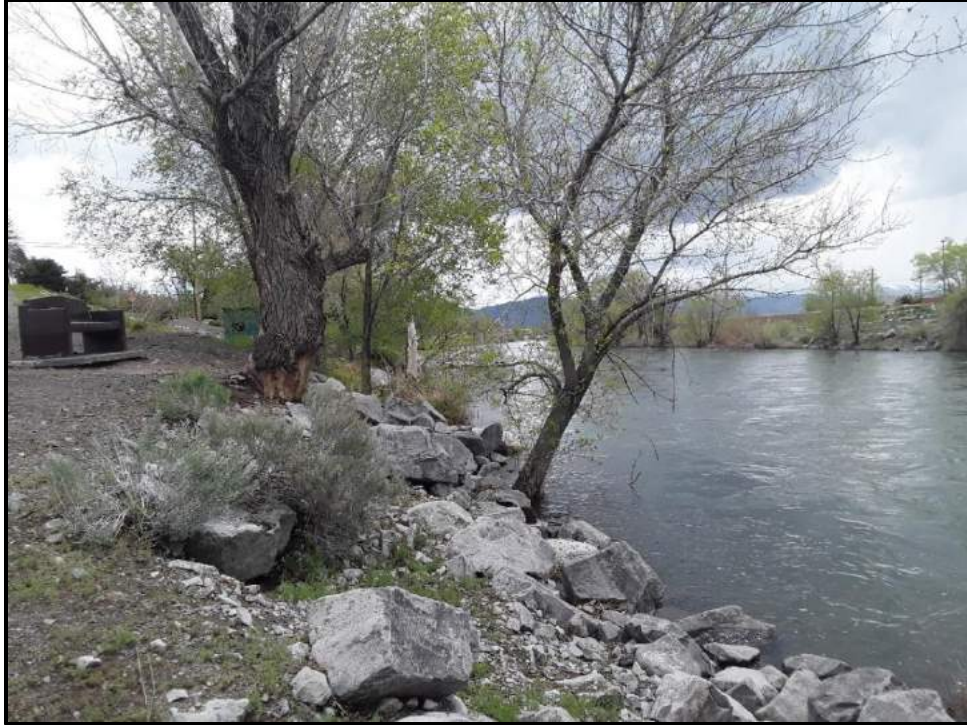
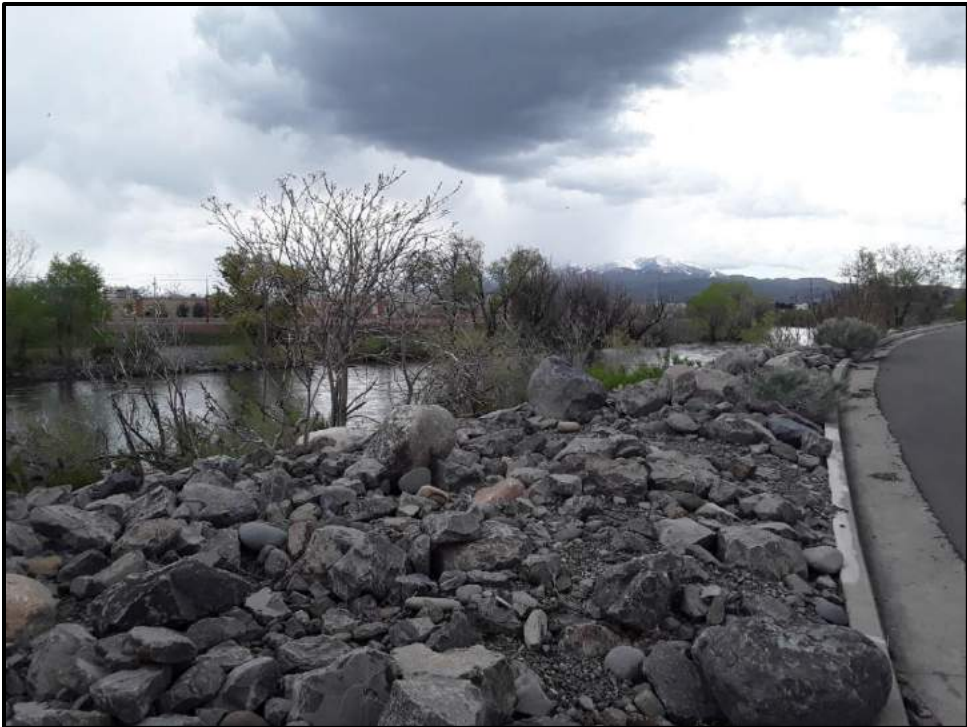
Photograph A-14. East end of Fisherman's Park. City of Reno and City of Sparks, L92. Steep slope with bare areas and one area with riprap. This area has very low vegetation cover (L92).

Photograph A-15. East end of Fisherman's Park (L92).
